INDOOR AIR QUALITY ASSESSMENT

**Homer Street Elementary School
43 Homer Street
Springfield, Massachusetts**

Prepared by:
Massachusetts Department of Public Health
Bureau of Environmental Health Assessment
July, 2002

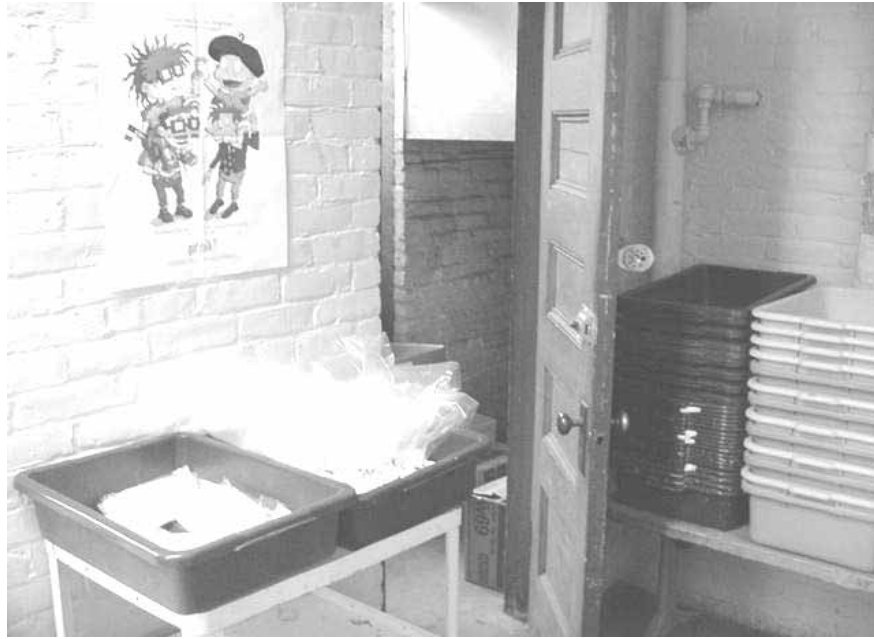
Picture 1

Door To Air Mixing Room Ajar in Kitchen

4. Use the sash windows in air mixing rooms to introduce fresh air into the building.
Close doors in the air mixing room during the operation of the ventilation system.

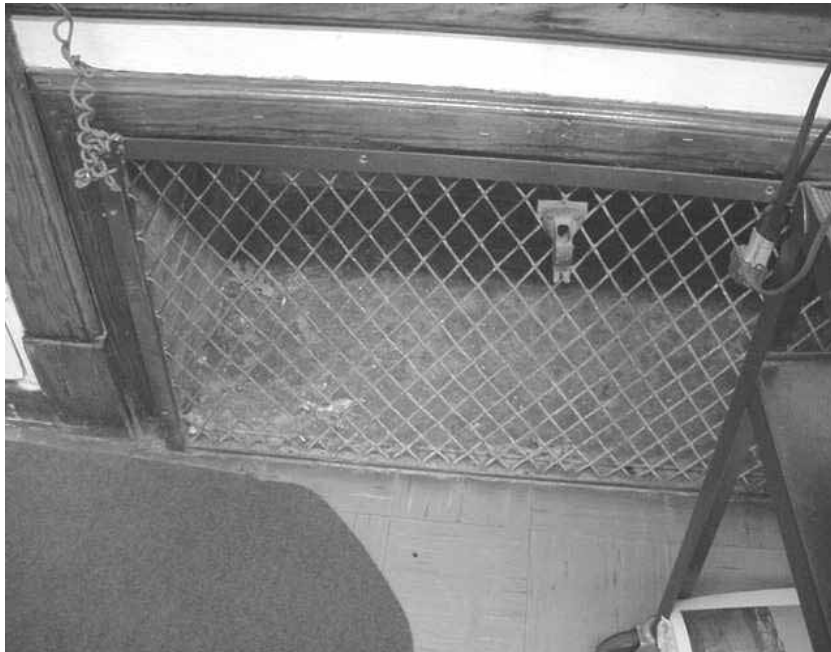
Picture 2

The 1898 and 1920/1925 wings have differently designed exhaust ventilation systems. The 1898 wing is drawn from the classroom into a grated hole located at floor level (see Picture 2). No airflow was detected in any exhaust vents examined. A flue located inside the duct controls airflow. Above the flue is usually a heating element that creates ventilation in the same method as the fresh air supply system. Exhaust vents terminate on the roof (see Picture 3).

Typical Exhaust Vent In 1898 Building Section

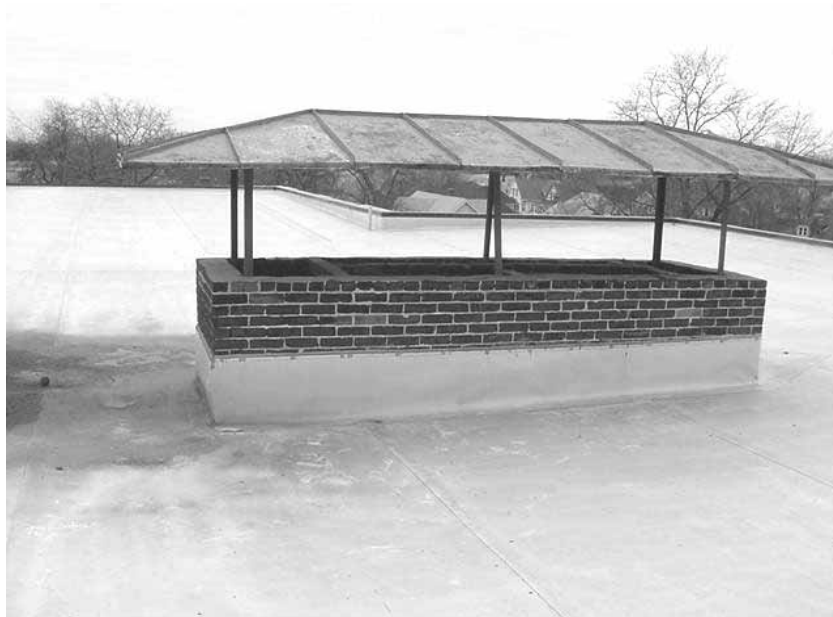
Picture 3

Exhaust Vent Terminus on Roof Of 1898 Wing

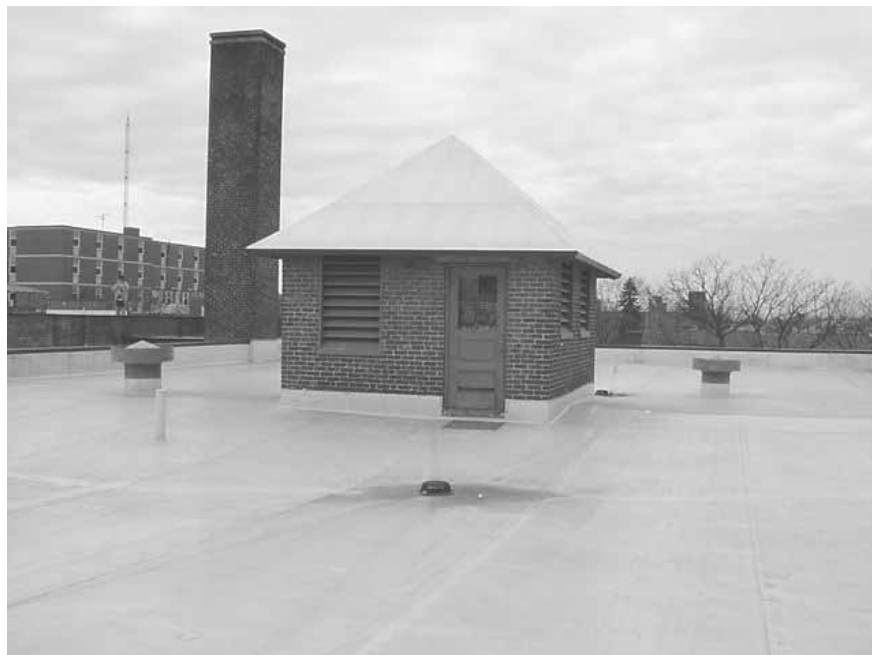
Picture 4

The 1920/1925 wing had exhaust ventilation provided by large fans located in a brick cupola on the roof (see Pictures 4, 5 and 5A). Each fan is connected to classrooms by ductwork to a vent located on the interior wall of each classroom at floor level. The draw of air into these vents is controlled by a draw chain pulley system. The motor and fan belt for the exhaust system had been removed, rendering it inoperable. Without exhaust ventilation, environmental pollutants can build up in the indoor environment and lead to air quality complaints and discomfort.

Cupola Housing 1920/1925 Wing Exhaust System

1. Implement corrective actions recommended in the letter concerning the kitchen stove as soon as possible (see Appendix III).
2. Under current conditions, openable windows and doors are the only source of ventilation within this building. Long term solutions are advisable. Use of openable windows to provide fresh air in the interim should be done in a manner to prevent damage to the heating system from freezing pipes.
3. If the ductwork is determined to be useable with repairs, the following activities should be done:
 - (a) Examine the feasibility of reestablishing ventilation control with existing ventilation equipment
 - (b) Repair the pulley chain/louver door systems in vents to provide ventilation as designed.
 - (c) Repair control systems for fresh air intake vents.
 - (d) Repair the exhaust vent motors in the 1920/1925-wing cupola.

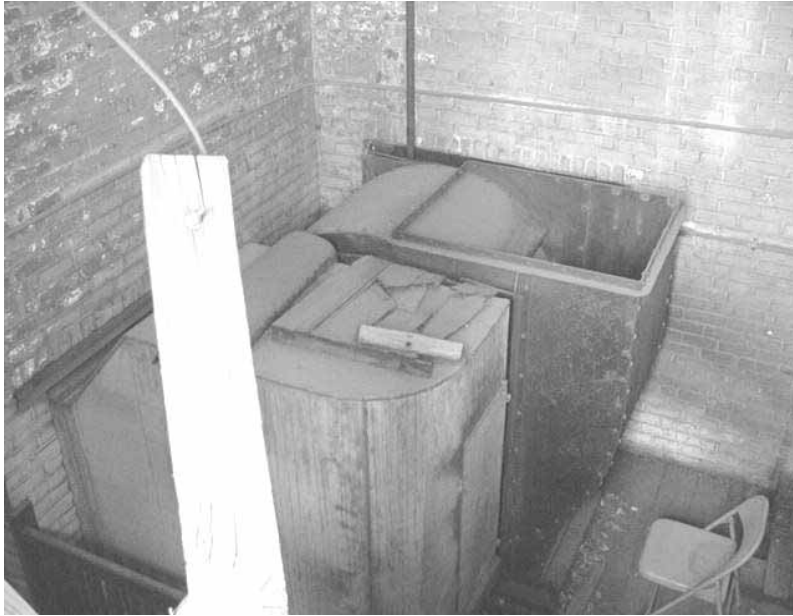
Picture 5

Abandoned Exhaust Fan System Of The 1920/1925 Wing

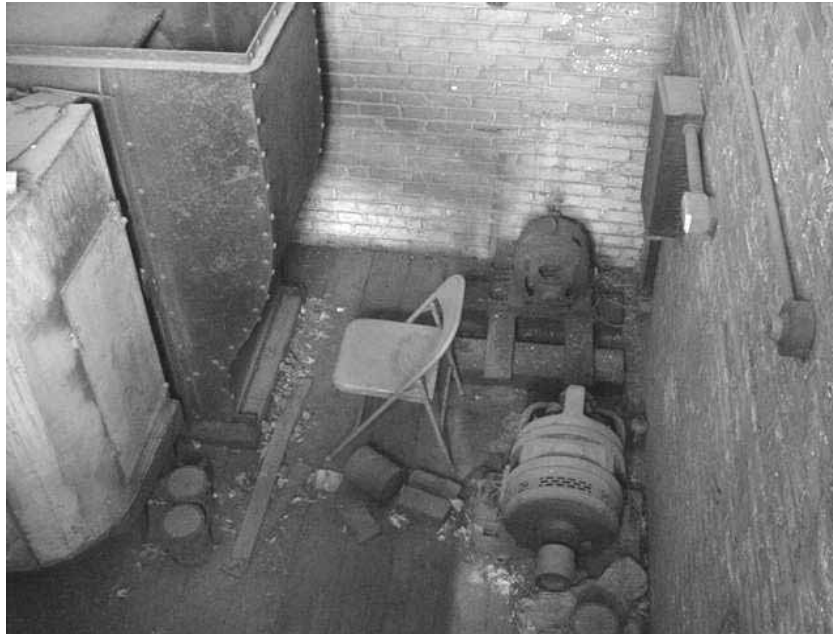
Picture 5A

Motors For the Abandoned Exhaust Fan System Of The 1920/1925 Wing

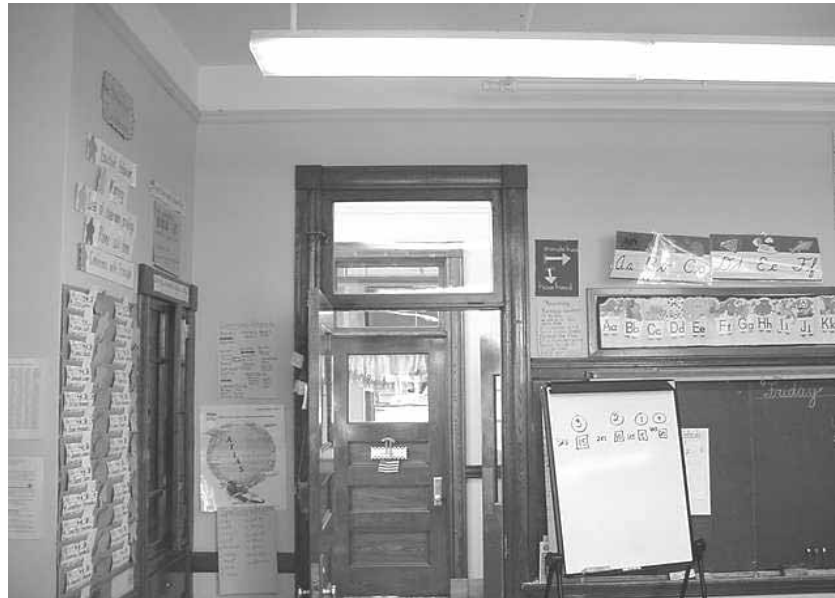
Picture 6

(see Figure 1). With all windows and transoms open, airflow can be maintained in a building regardless of the direction of the wind. This system fails if the windows or transoms are closed (see Figure 2). Transoms in the 1898 and 1920/1925 wings are opened using a rod/hinge system. Most transoms in these wings are inoperable or closed. Some transoms are fixed in the closed position with nails.

Typical Transom over Classroom Hallway Door

5. Restore ability to open and close transoms. Use transoms to enhance airflow during warm weather. Be sure to close transoms at the end of the school day. To aid in the draw of fresh outdoor air in warm weather, use portable fans directing air out windows on the leeward side of the building. Fans positioned in this manner will serve to increase the draw of outdoor air across a floor without interfering with the natural internal airflow pattern of the building. To aid cross ventilation, open hallway doors in areas with inoperable transoms.

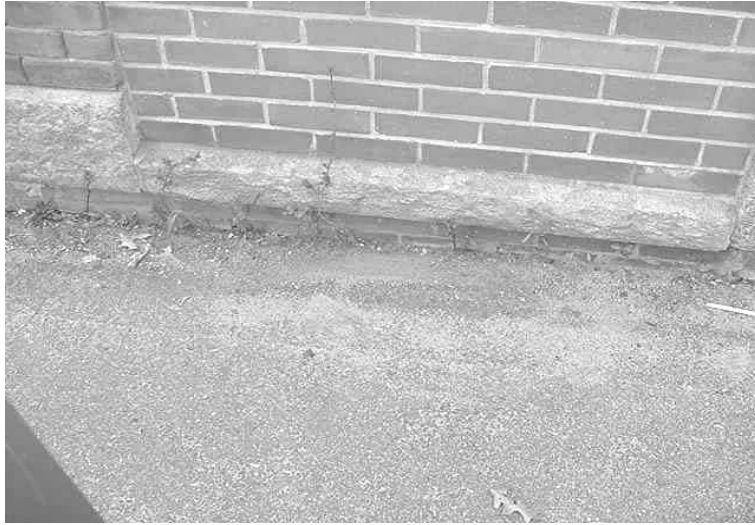
Picture 7

- Plants were noted growing in the junction between the exterior wall and the tarmac (see Picture 7). Water can gather in the wall/tarmac seam where these plants were observed. Freezing and thawing of gathered water can result in damage to the exterior wall, which can result in water penetration into the building.
- Shrubbery in direct contact with the exterior wall brick was noted in several areas around the building (see Picture 8). Shrubbery can serve as a possible source of water impingement on the exterior curtain wall due to the location of plants growing directly against the building. Plants retain water and in some cases can work their way into mortar and brickwork causing cracks and fissures, which may subsequently lead to water penetration and possible mold growth.
- The exterior wall above the basement hallway has a number of holes and deteriorated mortar (see Picture 9).

Plants Growing in the Junction between the Exterior Wall and The Tarmac

15. Remove all vegetation from the exterior wall/tarmac seam. Seal the exterior wall/tarmac junction with a water impermeable sealant.
16. Discontinue the use of tennis balls on chairs to prevent latex dust generation.

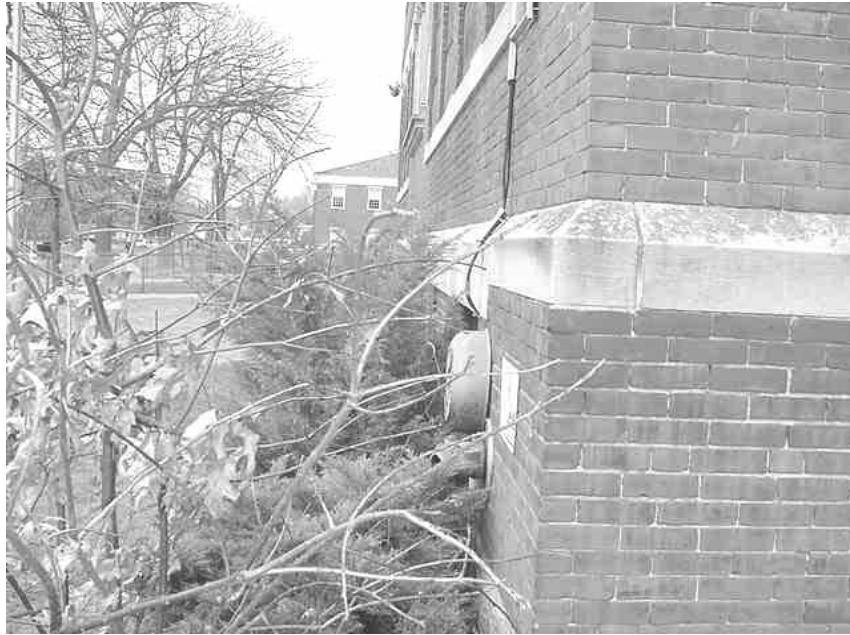
Picture 8

Shrubbery in Direct Contact with the Exterior Wall Brick

13. Cut back or consider removing shrubbery from the exterior wall of the front of the building.
14. Install a gutter/downspout on the peaked roof in Picture 12.

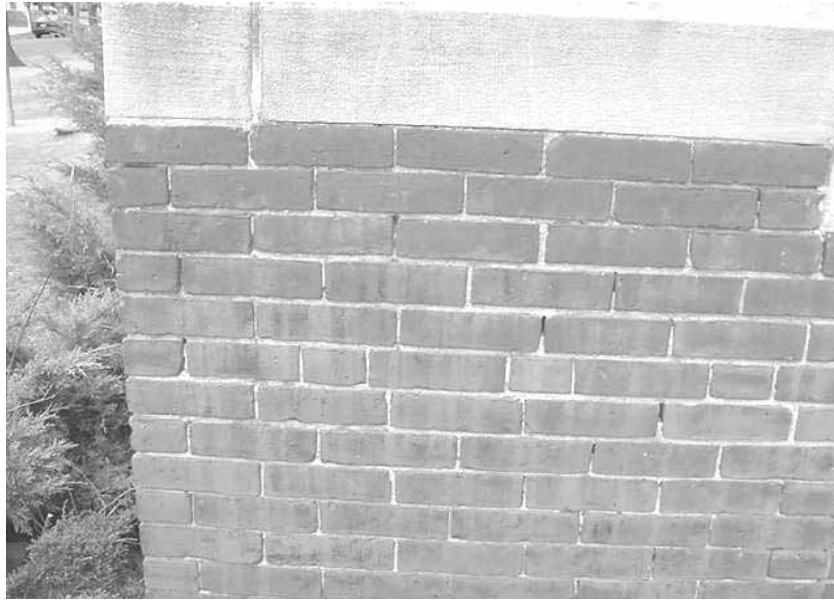
Picture 9

Deteriorated Mortar between Bricks of the Exterior Wall

9. Consider having exterior brick repointed to prevent further moisture penetration and subsequent water damage.

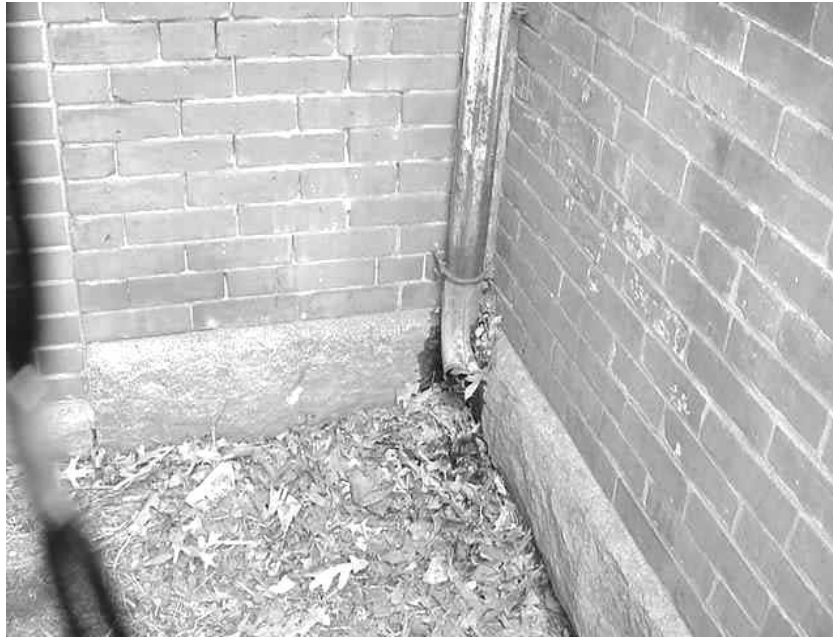
Picture 10

- Downspouts empty at the exterior wall/ground junction onto leaves (see Picture 10) or several feet above ground level, which allows rainwater to impact on the ground below and chronically wet sections of the exterior walls. Downspouts should be designed to direct rainwater away from the base of the exterior walls to prevent rainwater from pooling against foundation walls. The wetting of exterior walls and crawlspace soil can result in mold growth.

Downspouts for This System Empty at the Exterior Wall/Ground Junction onto Leaves

10. Remove the sand pile from close proximity to the boiler room.
11. Remove leaves from the base of the building.
12. Improve drainage along the exterior wall to direct rainwater away from the base of the building.

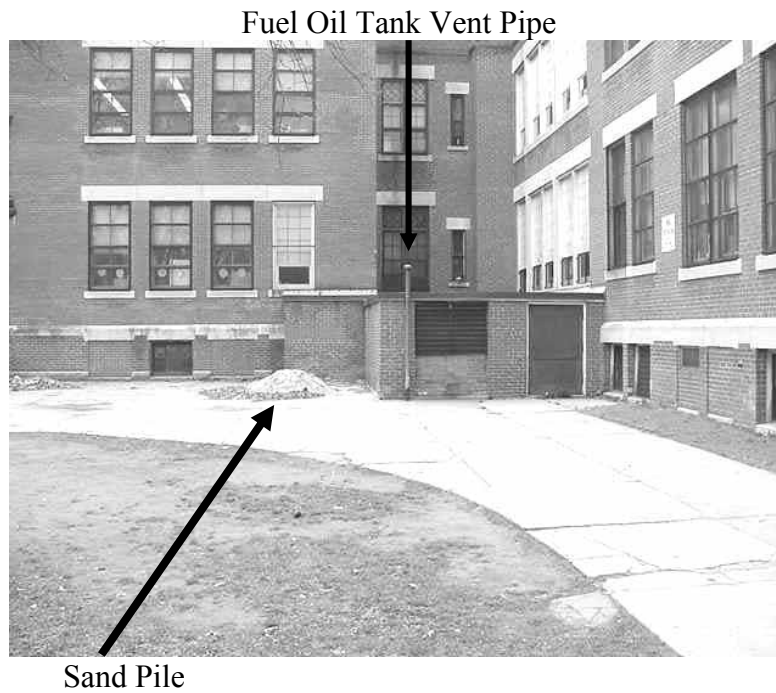
Picture 11

- Piles of accumulated leaves in corners of the building can serve to hold moisture against exterior wall materials and increase moisture penetration.
- A large pile of sand exists outside the boiler room exterior wall (see Picture 11). Water runoff from the short roof onto the ground, combined with the sand pile, can hold moisture in this area, enhancing water penetration seen in the boiler room. The worst water damage in the boiler room exists directly opposite this sand pile.

Several complaints of vehicle exhaust and fuel oil odors during fuel delivery were also reported. The pressure relief vent for the underground storage tank is located at the corner of the boiler room roof (see Picture 11). Under certain wind conditions, fuel oil vapor may be directed toward the classrooms adjacent to the boiler room roof. Cars are also parked at the base of the exterior wall near fresh air intakes for the unused ventilation system of the 1920/1925 wing (see Picture 20). Idling vehicles can result in vehicle exhaust infiltration into the building. In turn this can provide opportunities for exposure to products of combustion, including carbon monoxide. M.G.L. chapter 90

**Pile Of Sand outside Boiler Room, Note Oil Tank Vent Pipe
Location at Same Level as Windows**

21. Schedule oil deliveries after school or when school is not occupied. If not feasible, notify school staff including classroom occupants in close proximity to the oil tank, in advance of scheduled delivery. This will avoid fuel odors/vehicle exhaust entrainment into classrooms.

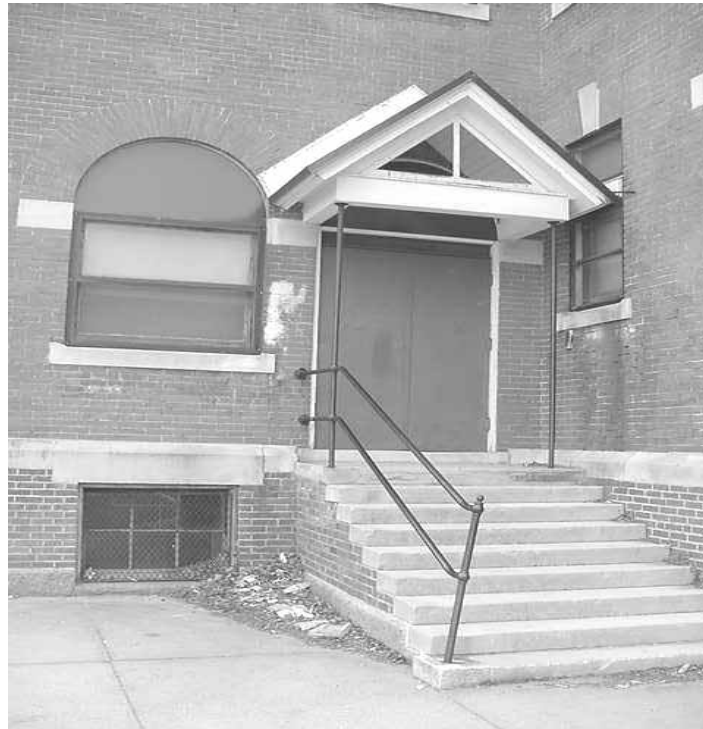
Picture 12

- A peaked roof exists over a door at the rear of the school (see Picture 12). Water from half of this roof is directed toward a wooden window frame.
- A plant was growing inside the wire mesh on one ground floor window (see Picture 13). The presence of this plant indicates a sufficient water supply is wetting the material on top of this window frame to support plant growth.

Peaked Roof over Doorway That Directs Rainwater toward Window

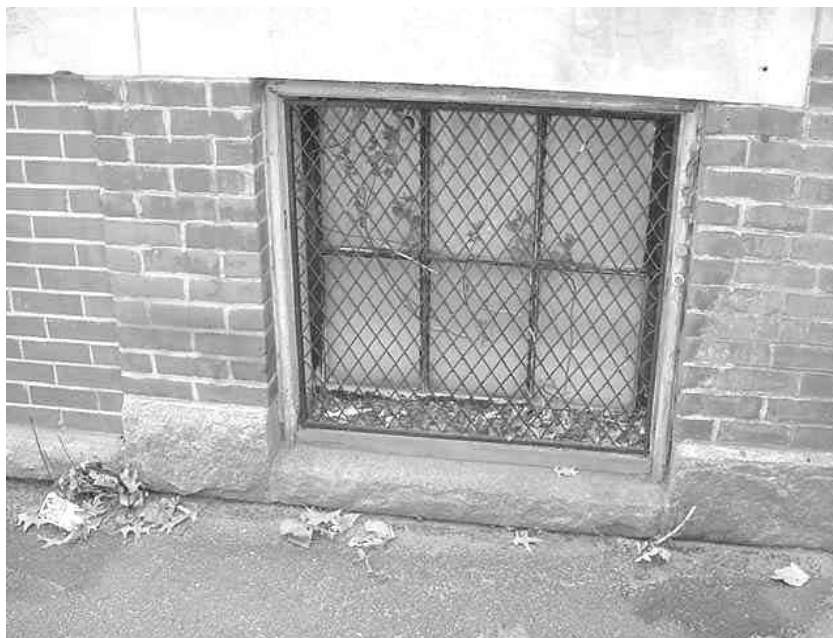
Picture 13

Plant Growing in Ground Floor Window Frame

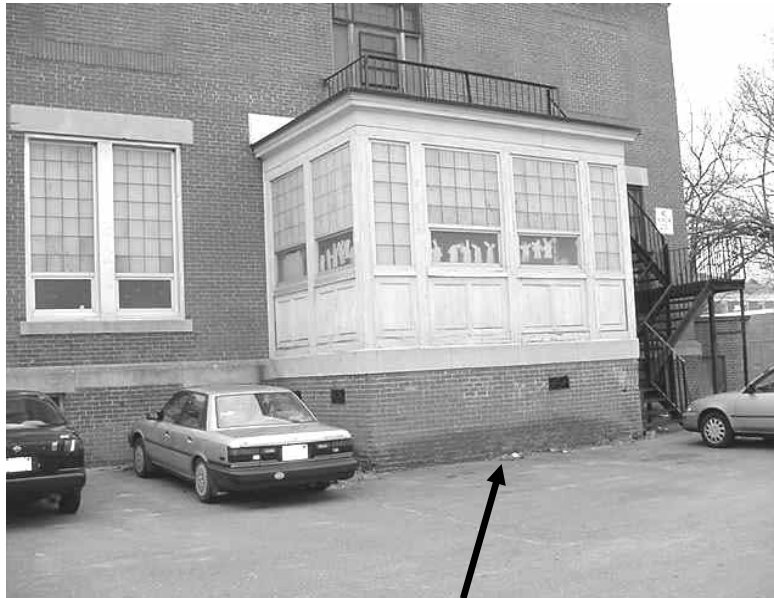
Picture 14

- The roof over the classrooms of the 1925 addition does not have a gutter/downspout system. Rainwater rolls from the roof to chronically wet the foundation wall (see Picture 14).

The Roof over the Classrooms Of the 1925 Addition Does Not Have A Gutter/Downspout System, Note Water Stain at Base of Exterior Wall

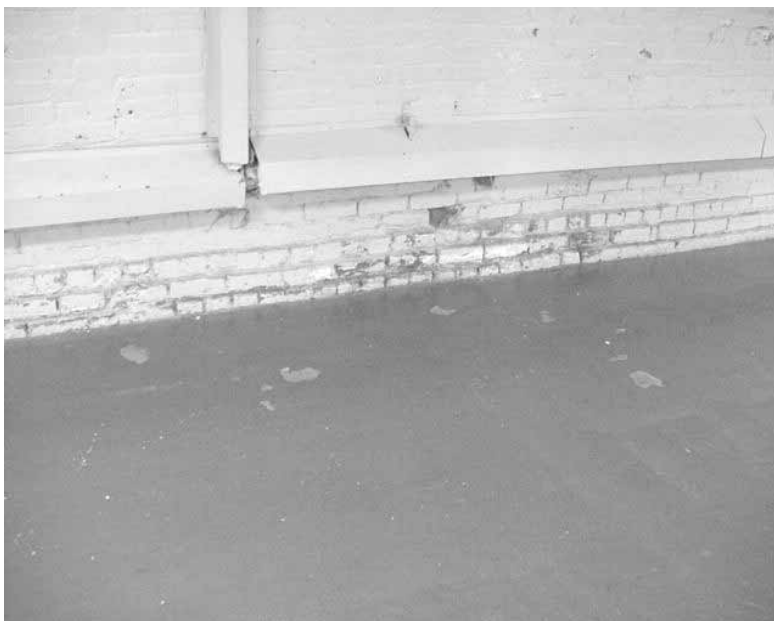
Picture 15

Efflorescence (i.e. mineral deposits) was observed on the brickwork on the interior walls in a basement hallway with peeling paint (see Pictures 15 & 16) as well as the interior wall of the boiler room. Efflorescence is a characteristic sign of water intrusion. As moisture penetrates and works its way through mortar around brick it leaves behind these characteristic mineral deposits. This condition indicates that water from the exterior is penetrating into the building. Water damaged materials such as wall plaster can serve as a medium to support mold growth.

Peeling Paint and Efflorescence in Ground Floor Hallway Of 1898 Wing

7. Ensure plants have drip pans. Examine drip pans periodically for mold growth and disinfect with an appropriate antimicrobial where necessary.
8. Repair/replace water damaged plaster. Examine surrounding non-porous areas for mold growth and disinfect with an appropriate antimicrobial if necessary.

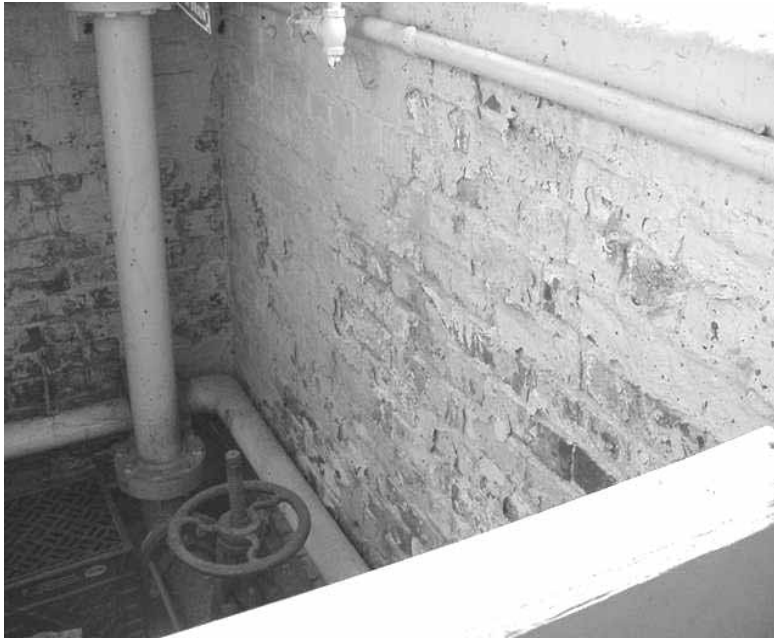
Picture 16

Efflorescence on Exterior Wall of Basement

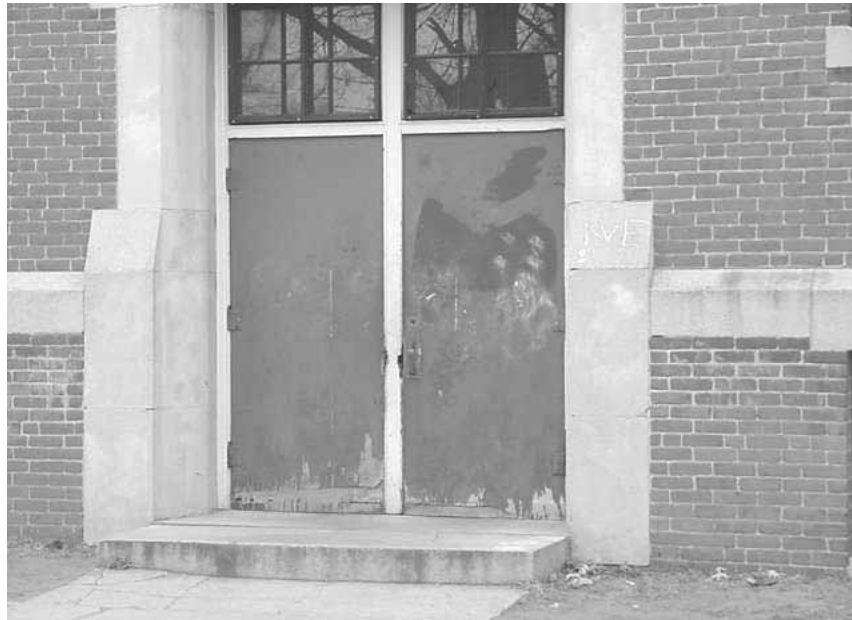
Picture 17

Several exterior doors appear to have water penetration through the door frame as noted by signs of water damage to the exterior of the door (see Picture 17). As with other porous building materials, if wood is not dried within 24 hours, mold growth may occur. Water-damaged wood may not be adequately cleaned to remove mold growth in some instances. The application of a mildewcide to moldy wood is not recommended.

Water Damaged Exterior Door

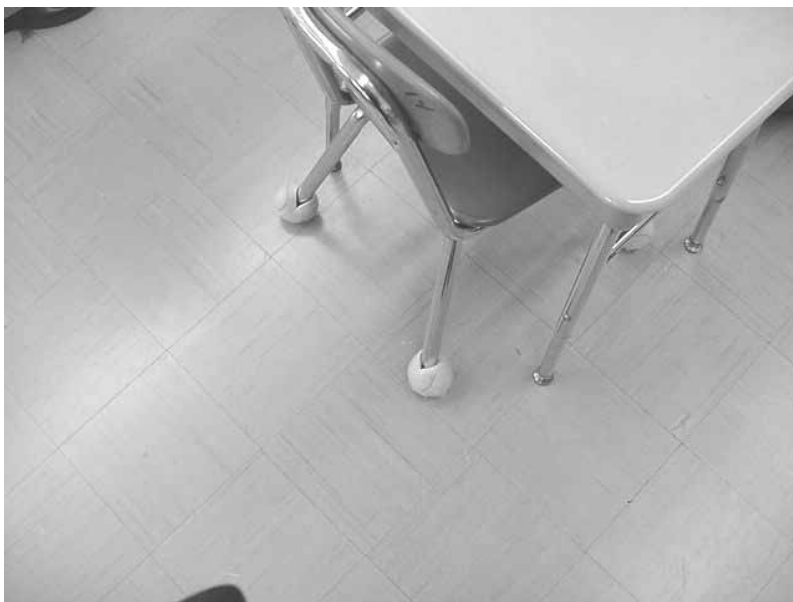
Picture 18

In an effort to reduce noise from sliding chairs, tennis balls are sliced open and placed on chair legs (see Picture 18). Tennis balls are made of a number of materials that are a source of respiratory irritants. Constant wearing of tennis balls can produce fibers

and off-gas volatile organic compounds (VOCs). Tennis balls are made with a natural rubber latex bladder, which becomes abraded when used as a chair leg pad. Use of tennis balls in this manner may introduce latex dust into the school environment. Some individuals are highly allergic to latex (e.g., spina bifida patients) (SBAA, 2001). It is recommended that the use of materials containing latex be limited in buildings to reduce the likelihood of symptoms in sensitive individuals (NIOSH, 1998). A question and answer sheet concerning latex allergy is attached as [Appendix II](#) (NIOSH, 1997).

Tennis Balls On Chair Legs

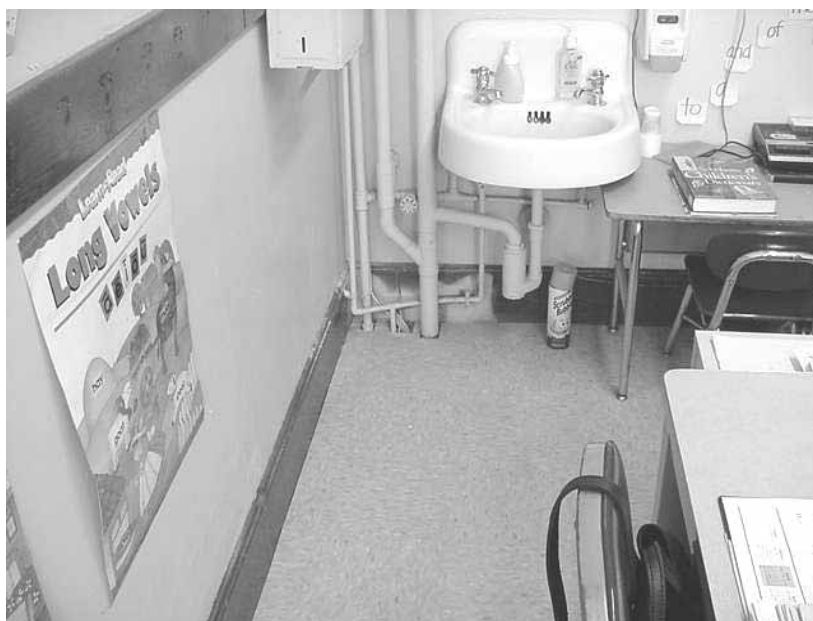
Picture 19

Open holes around utility pipes were noted in the floors and ceilings in classrooms (see Picture 19). Open pipes and utility holes can provide a means of egress for odors, fumes, dusts and vapors from the storage space into classrooms.

Holes Around Drain Pipes in Floor

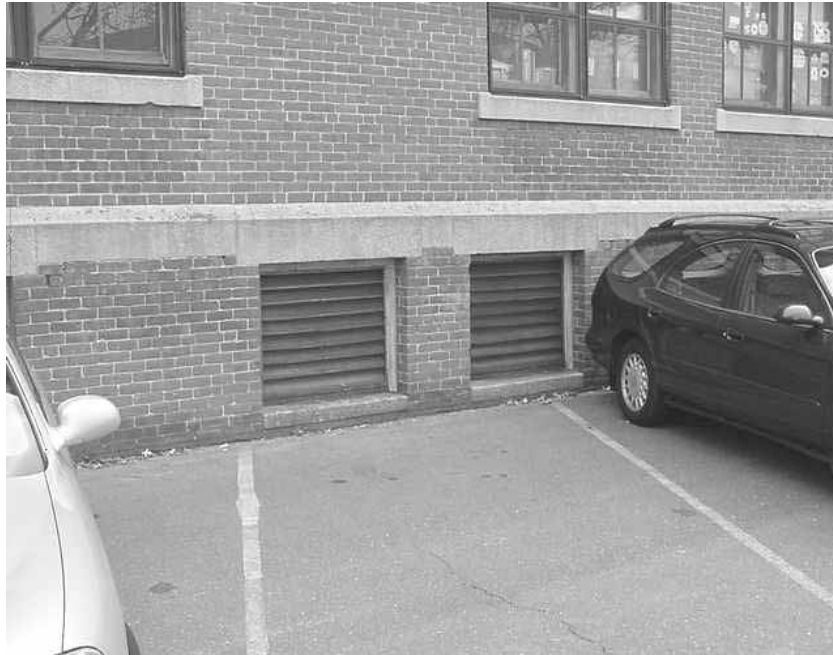
Picture 20

**Cars Parked At the Base of the Exterior Wall near Fresh Air Intakes for the Unused Ventilation System
Of The 1920/1925 Wing**

22. Consider relocating parking spaces away from the building to prevent vehicle exhaust from being entrained by open windows.
23. Seal the abandoned chimney at roof level to prevent rainwater penetration and animal egress.

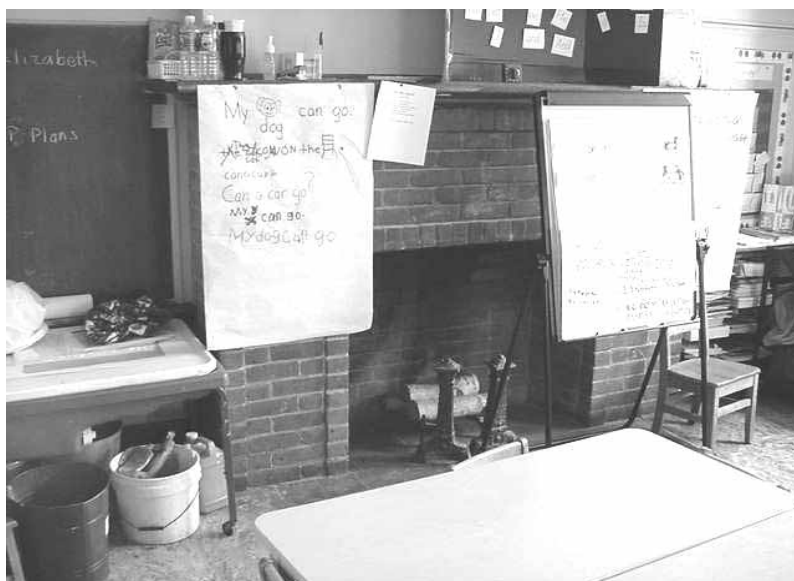
Picture 21

A fireplace exists in classroom 8B (see Picture 21) which appeared to be no longer in use. The chimney for the fireplace is on the roof (see Picture 22). The top of the chimney is open, which can allow rainwater to penetrate down the shaft. In addition, animals may also enter the building through the chimney as well as via the 1898 exhaust vent termini.

Fireplace in Classroom 8B

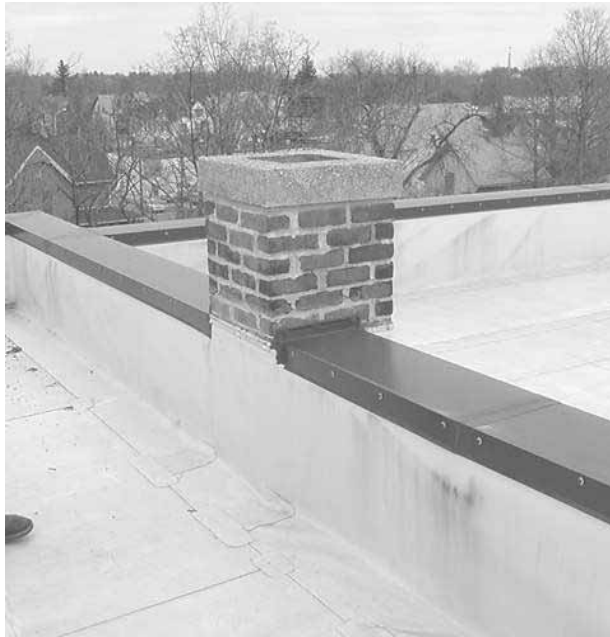
Picture 22

Chimney on Roof

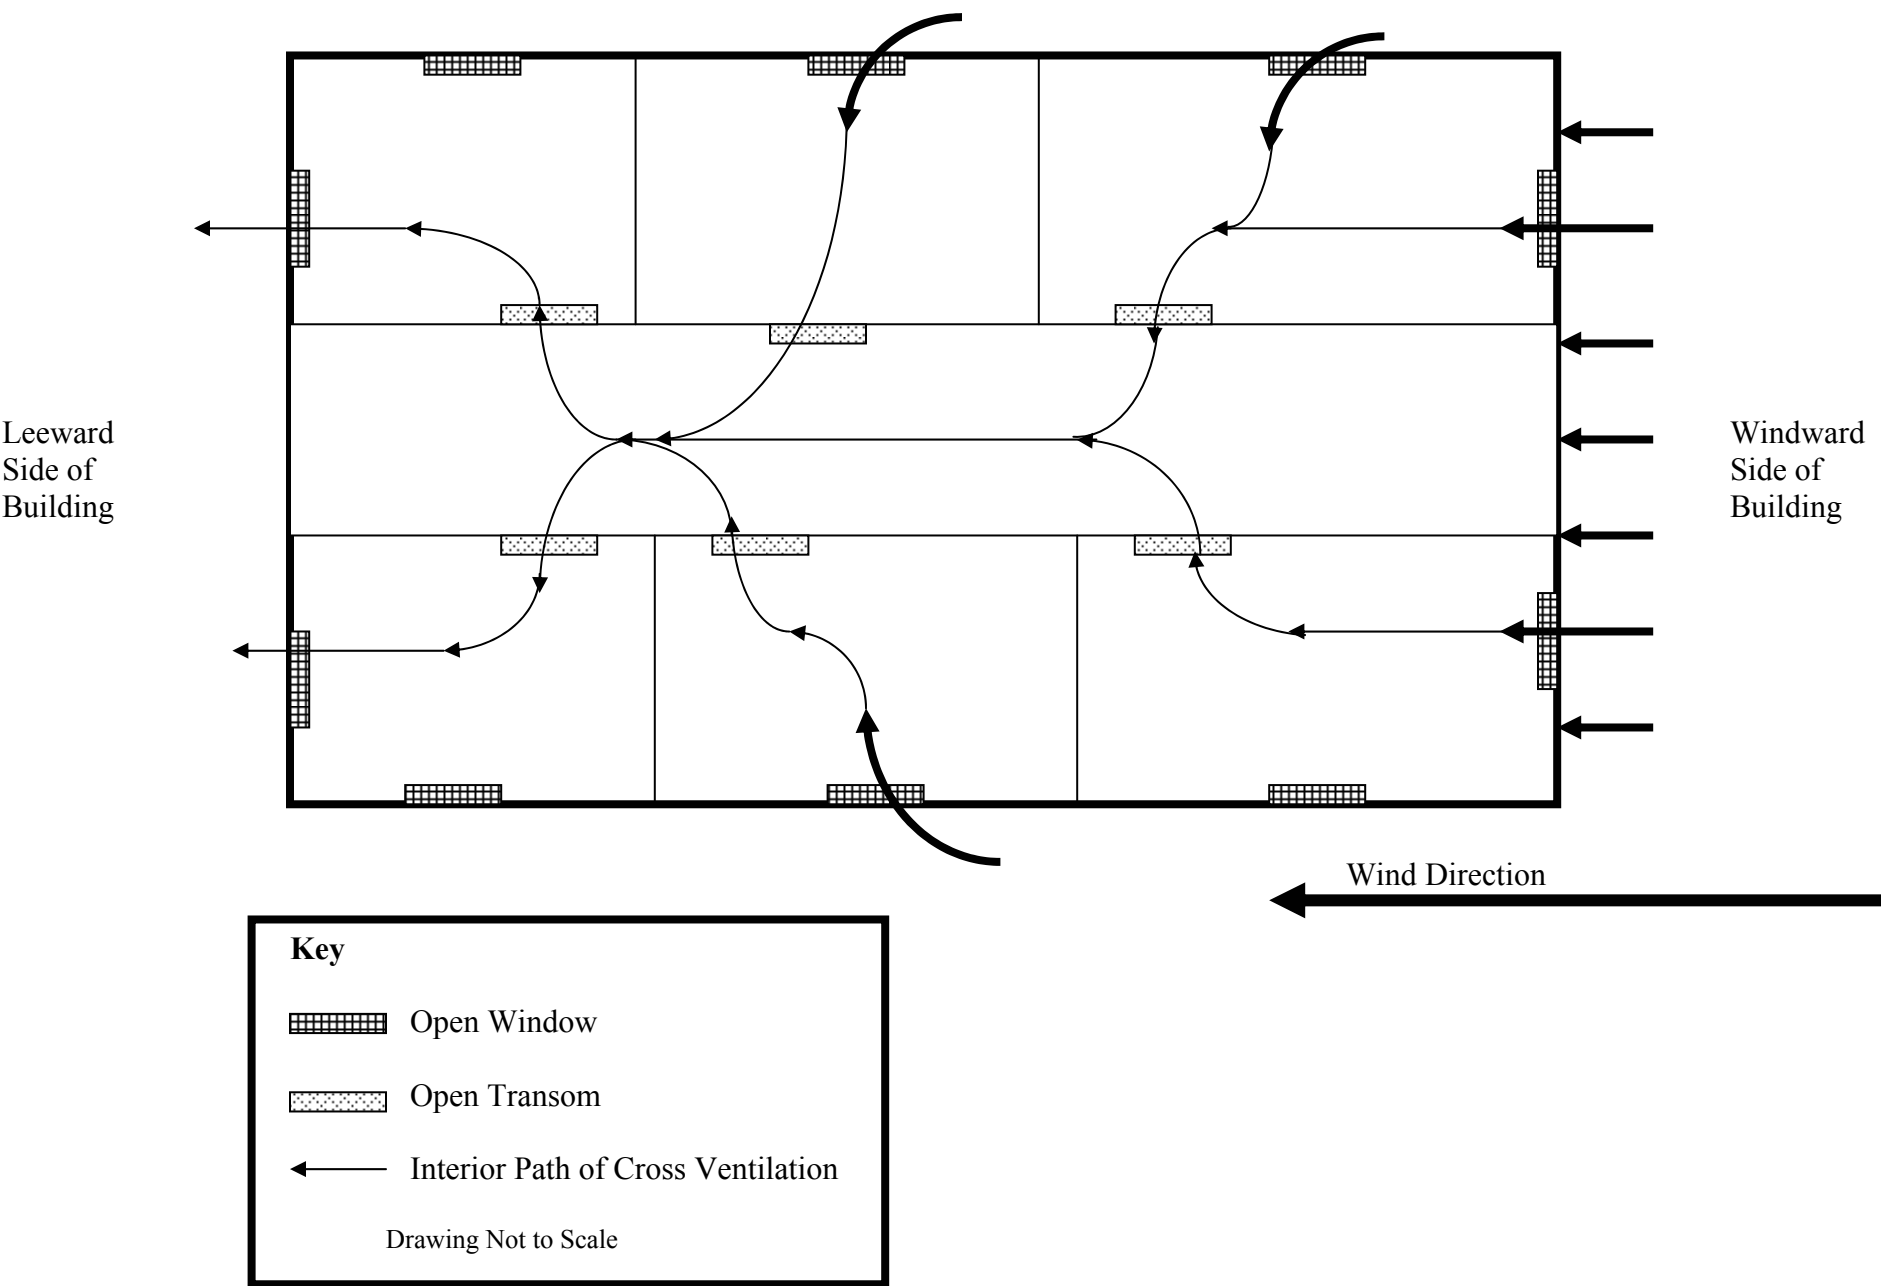
Figure 1

Cross Ventilation in a Building Using Open Windows and Transoms

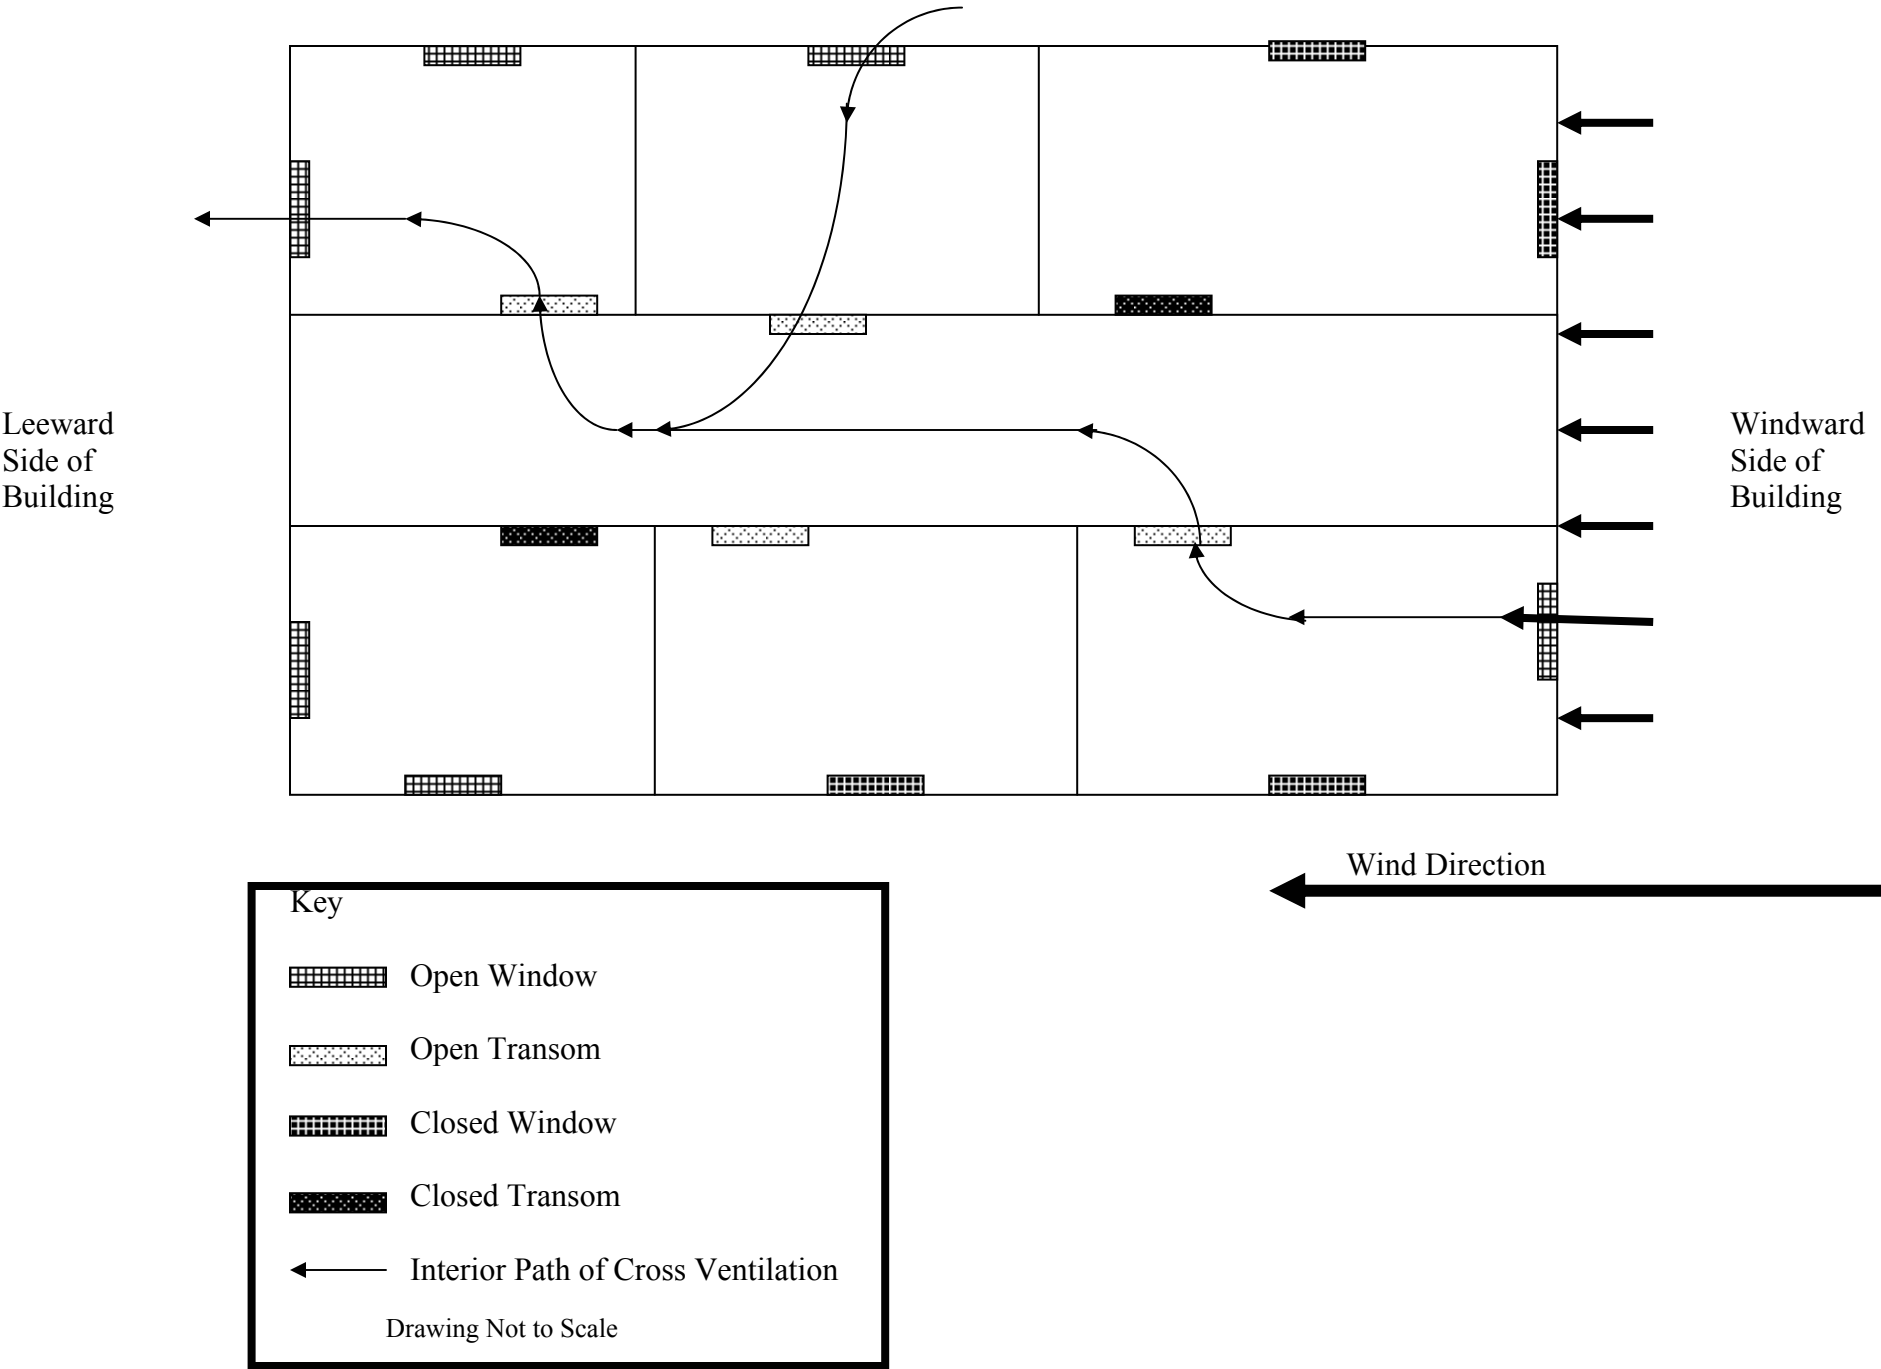
Figure 2

Inhibition of Cross Ventilation in a Building with Several Windows and Transoms Closed
